COMMERCIAL INSPECTION REPORT

Prepared For: Client Name

8/22/2024

1234 Address Rd
, IL

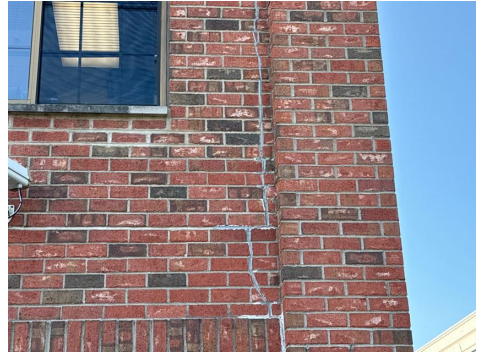
- Typical settlement cracks were observed at one or more areas. They commonly occur in the first few years after the building is completed and do not usually indicate a structural deficiency. Monitoring of the cracking is suggested. If the cracking appears to increase in size or area, then additional review is recommended.

Settlement Cracks

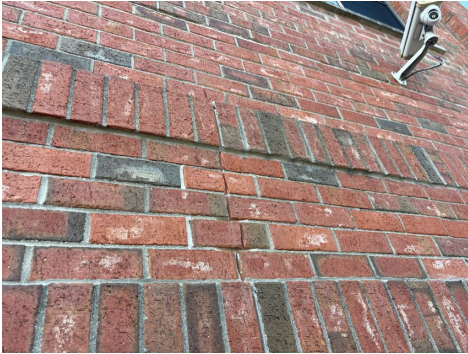
Settlement Cracks

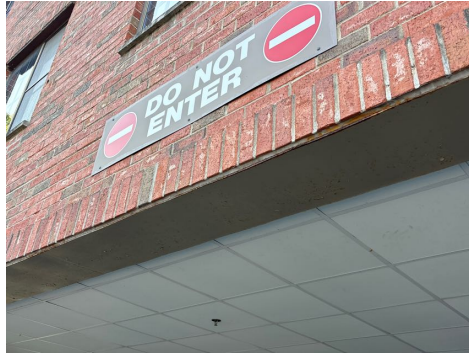
- Typical caulking maintenance is recommended at one or more areas in order to prevent moisture damage to the underlying wall surfaces.
- The majority of the steel lintel(s) of the garage area were found to no longer be flat and typical but rather have distortions and ripples. This is a sign of moisture and metal fatigue. Lintels are an essential part of the structure of the building and further review by a qualified structural contractor is recommended to determine the proper repair.

Rusting lintel

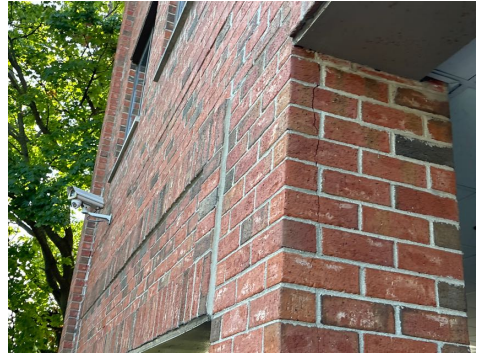
Settlement Cracks

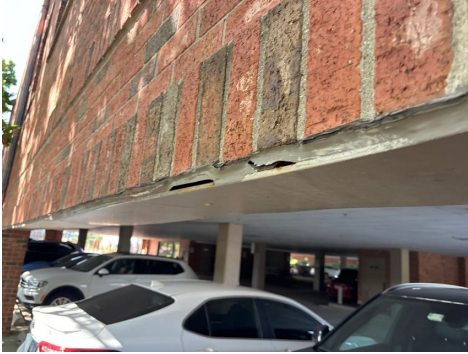
Lintel Distortion

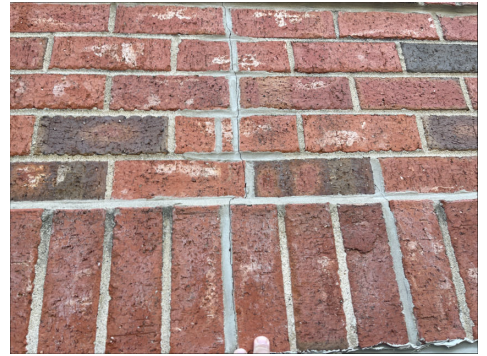
Cracks

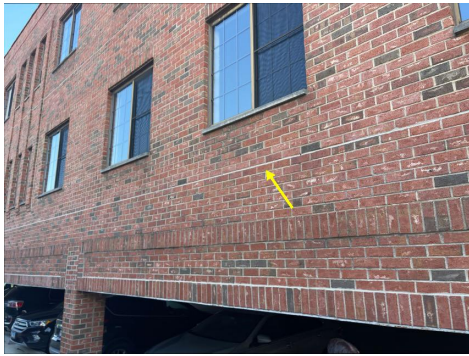
Recent repairs

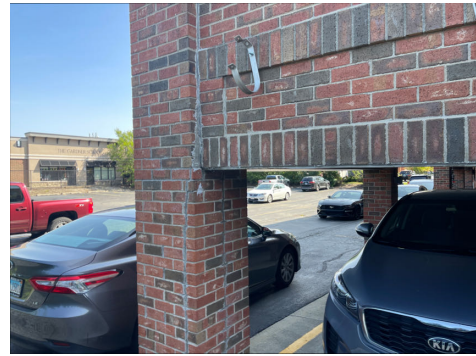
Cracks

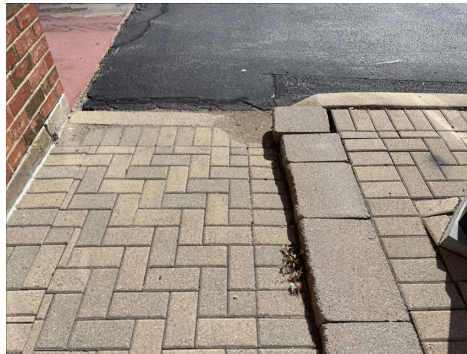
- Tripping hazards were noted at the following areas, front walk, loose paver.

Loose Paver

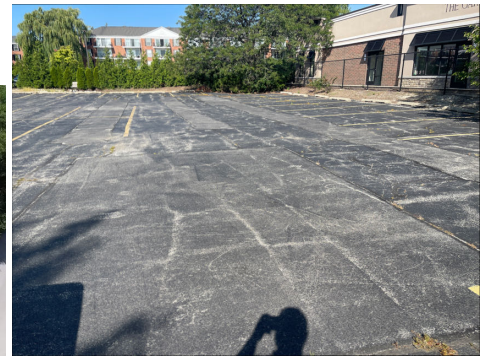
- All parking surfaces on the lot are paved with asphalt. Asphalt parking surfaces have a typical lifespan of 20-30 years with preventative maintenance.
- Typical settling cracks were noted. All concrete, asphalt and masonry cracks, (it's just a matter of degree), and the cracks observed appear to be normal.
- Potholes were found in the parking or driving area. While pot holes are normal they can cause not only vehicle damage but be a potential trip hazard. Filling them with the appropriate materials is recommended.
- The curbs were found to be in satisfactory condition with the exception of: displaced bumpers and spalling concrete on bumpers.
- **A seal coat is recommended within the next year to seal cracks and extend the life of the asphalt surface.**

Recommend sealing

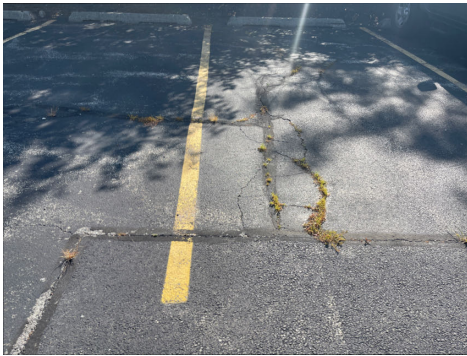
Recommend sealing

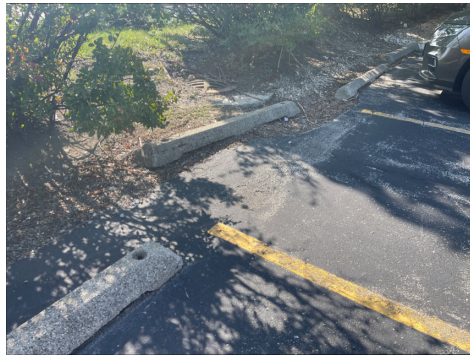
Displaced Bumpers

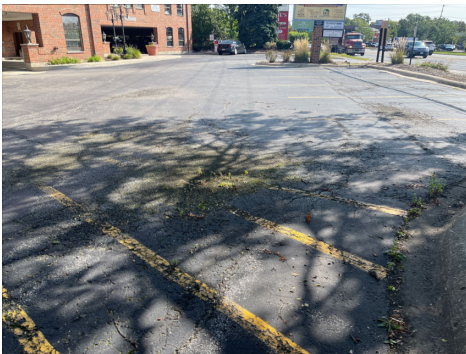
Recommend sealing

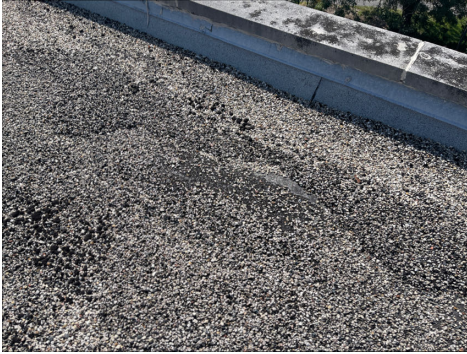
- The roof appears to have been patched or repaired in one or more areas. Recommend checking with the current owner as to the nature of the repair.
- The granular surface is beginning to show signs of deterioration from the ultraviolet rays of the sun, this is a normal sign of aging and indicates a limited life expectancy.
- Blisters were noted in one or more areas. This usually indicates there is moisture under the top layer of the roofing. Further evaluation by a qualified roofing contractor is recommended.

Blisters

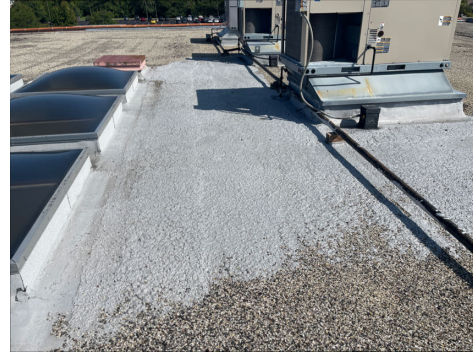
Repaired Area

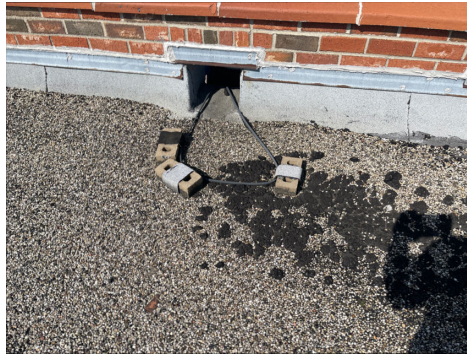
- Heat tape or drainage warmers have been added to the roof drainage. While these can help prevent gutters or drains from freezing they do require maintenance and attention. The installation can be a fire hazard when not properly maintained. The inspection or operation of this system is beyond the scope of this inspection.

Gutter Warmers

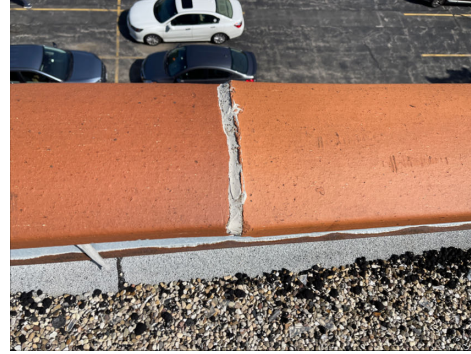
- The parapets appeared to be in satisfactory condition at the time of inspection.
- The parapet coping or flashing was noted to be sealed with caulk at the time of inspection. Caulk sealing can be an effective waterproofing method for a period of time. However, the seals will require periodic maintenance to ensure they remain waterproof.

Maintain Seams

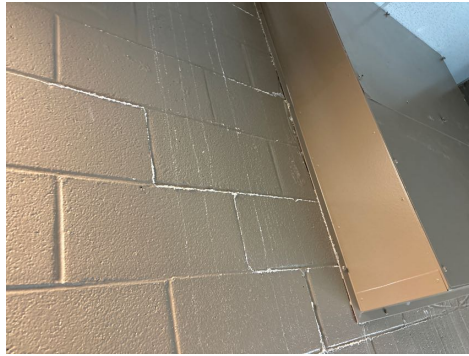
- Brick exterior walls exhibited areas of minor accumulation of efflorescence. Efflorescence is the brick surface accumulation of a white powdery residue that in small or moderate amounts is a cosmetic concern. Its presence is an indication that moisture has been seeping through the brick. To avoid possible worsening of this condition, you should consult with a qualified masonry contractor to discuss options and costs for correction; typically installing drainage holes.

Efflorescence-Stairway

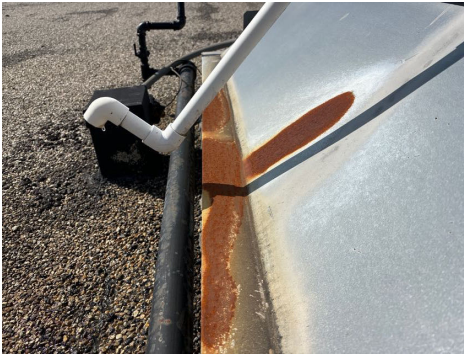
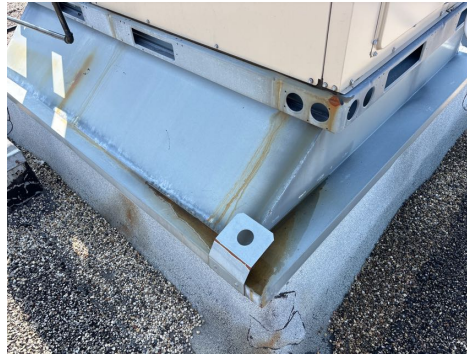
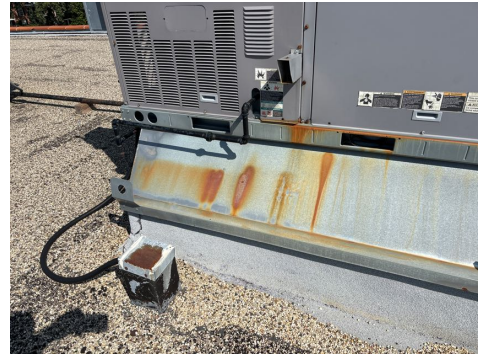
- Multiple RTU curbs were noted to be rusting at the time of inspection. It is recommended to apply rust proofing products to the curbs to prevent further deterioration.

Rust/Corrosion (Multiple Units)

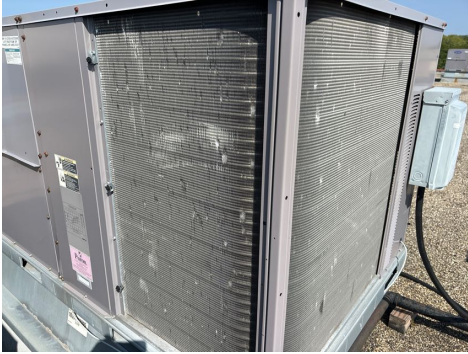
- Condenser coil fins of one or more HVAC rooftop unit (RTU) exhibited minor damage typical of that caused by hail. This condition may reduce system performance to some degree. Damage can sometimes be corrected by an HVAC service technician.

Damaged Fins-Suite 200 RTU

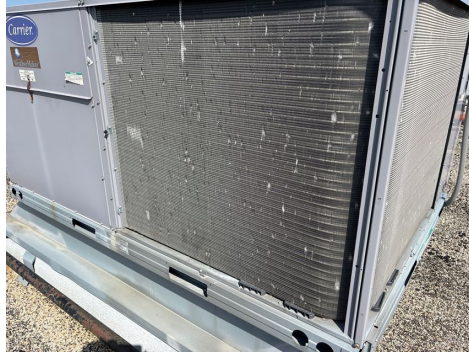
Damaged Fins-Suite 303 RTU

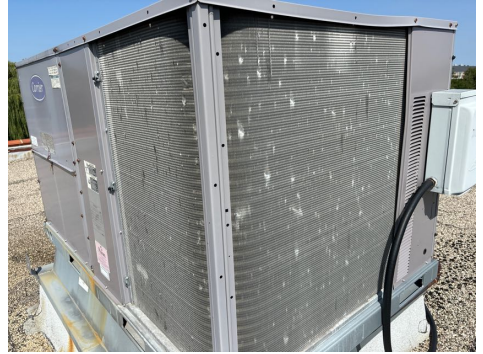
Damaged Fins-Suite 203

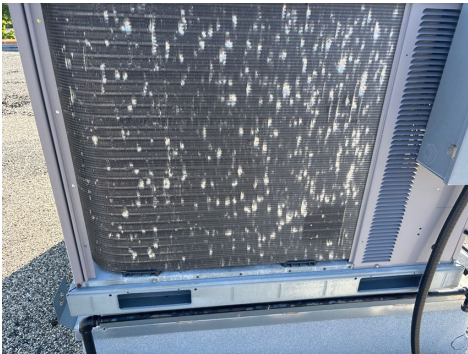
Damaged Fins-Unlabeled RTU

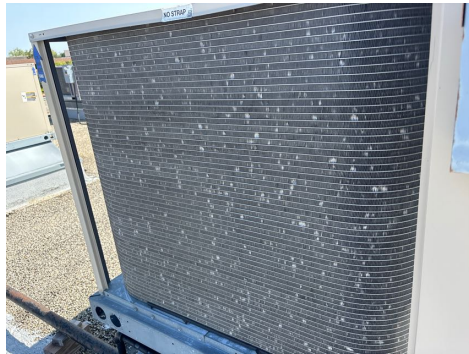
Damaged Fins-Suite 307 RTU

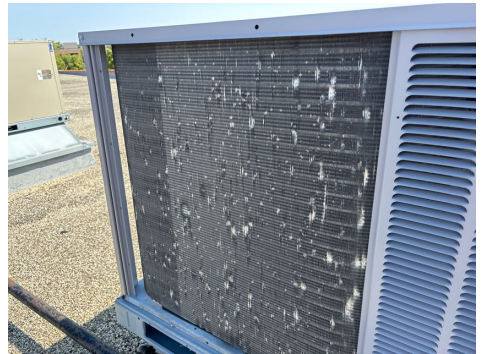
Damaged Fins-Suite 207 RTU

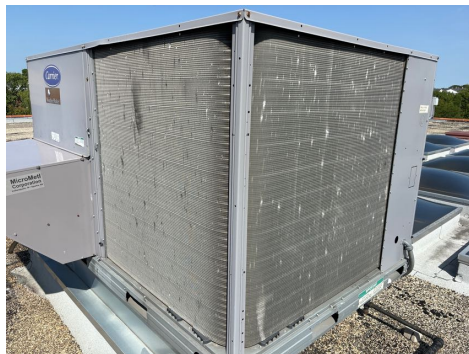
Damaged Fins-Atrium RTU

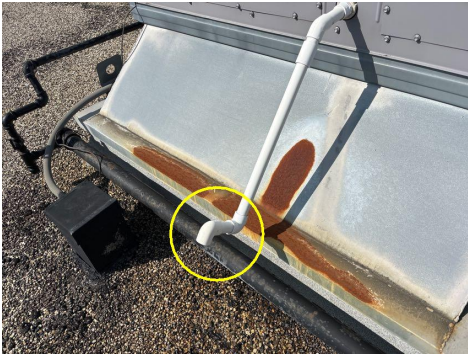
- Condensate from the evaporator coils of the HVAC rooftop units was discharged onto the surface of the roof. This condition is improper. Condensate should be discharged off the roof or to a roof drain.

All Units Discharge to Roof

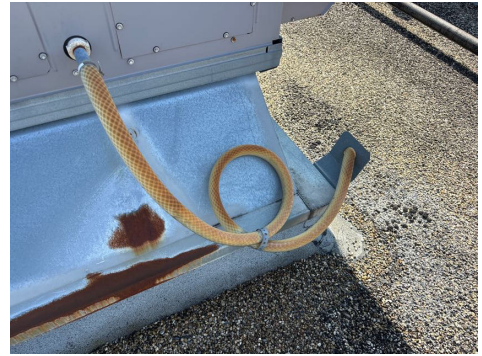
Improper Condensate Drain-
Atrium RTU

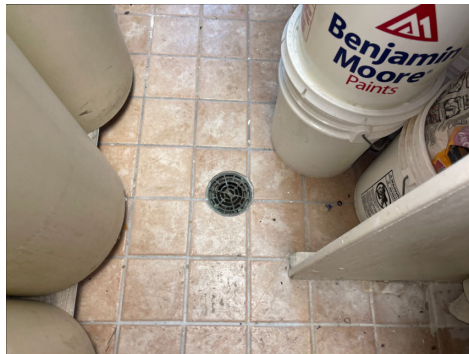
- Sewer odor was noted in the upstairs janitor closet, possibly due to a dry floor drain trap.

Sewer Odor

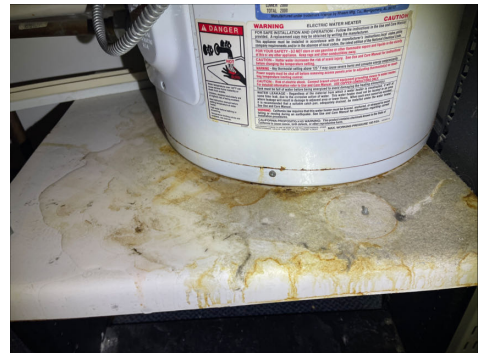
- This water heater was actively leaking and should be shut off, drained immediately and an an evaluation and any necessary work performed by a qualified HVAC or plumbing contractor.
- These water heaters appeared to be past their design life and may need replacement soon.

Leaking Water Heater 206

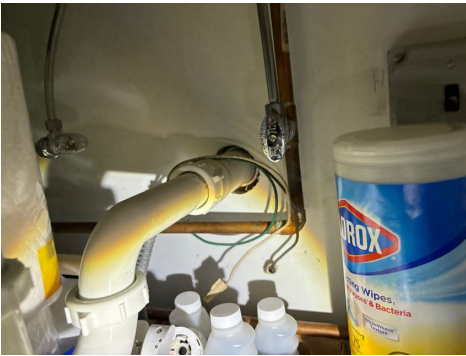
- A junction box installed in unit 206 was missing a cover and energized electrical components were exposed to touch. This condition is an electrical shock/electrocution hazard. A listed cover should be installed.
- Open electrical connections were observed in the undersink area of the Suite 302 Kitchenette.

Exposed Splices-Suite 302 Kitchenette

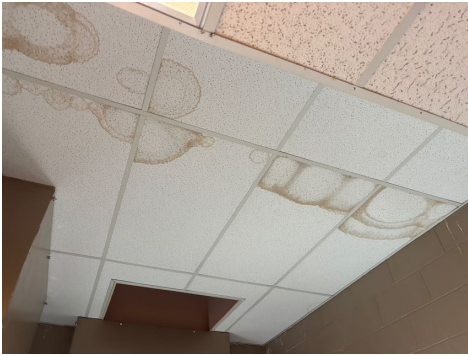
- These stains APPEAR to be the result of past, rather than current roof leakage or condensation leaks. However it is not possible to be absolutely certain.

Staining Noted (Dry)

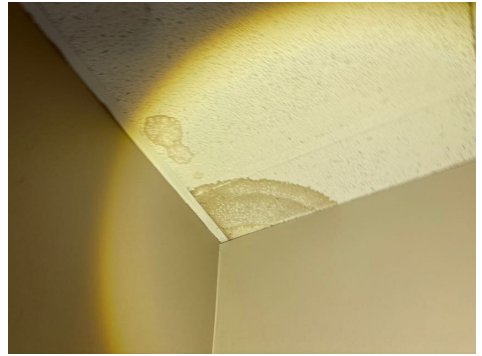
Suite 203 Staining-Dry

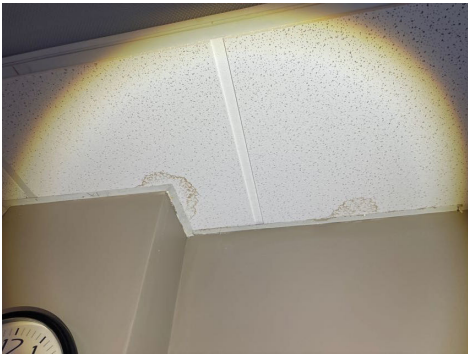
Suite 203 Staining-Dry

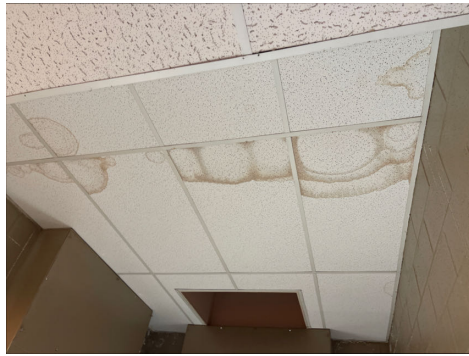
Water damage old

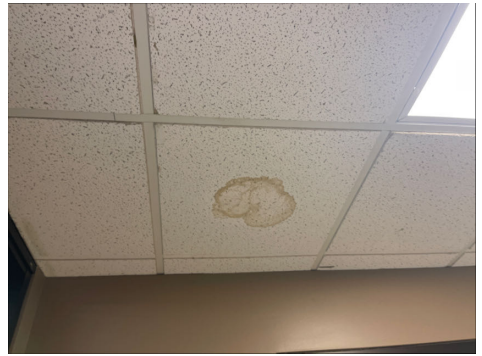
Water damage old

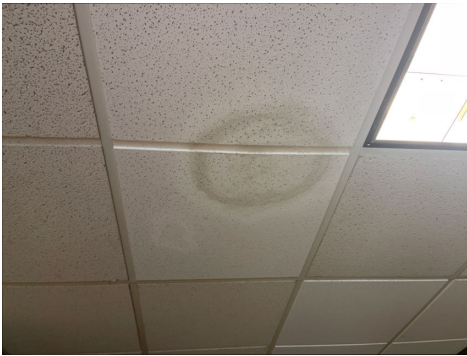
Water damage old

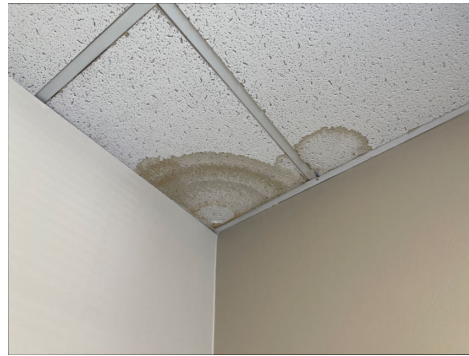
Water damage old

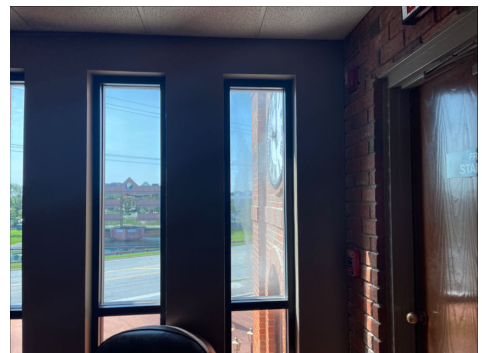
- The vacuum seal has failed ("lost seal") in the insulated glass in some of the windows. While the "fogging" of the glass is largely cosmetic, there is an accompanying loss of insulation value. This condition can only be corrected by replacement of the entire, factory assembled glazing unit by a qualified window contractor.

Lost Seal

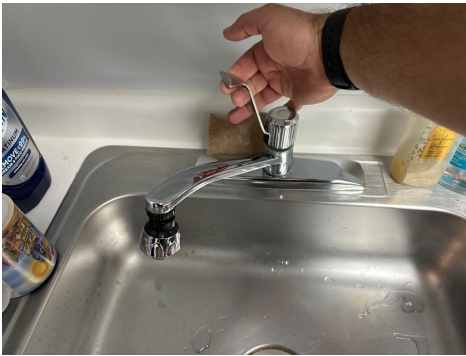
The faucet was dripping. This is wasteful and can substantially increase the water bill. Proper correction is recommended.

Operation of this item was attempted but not successful during the inspection. Further evaluation by a qualified contractor is recommended to determine why this item will not operate and to perform corrections.

Inoperable Faucet-Suite 302

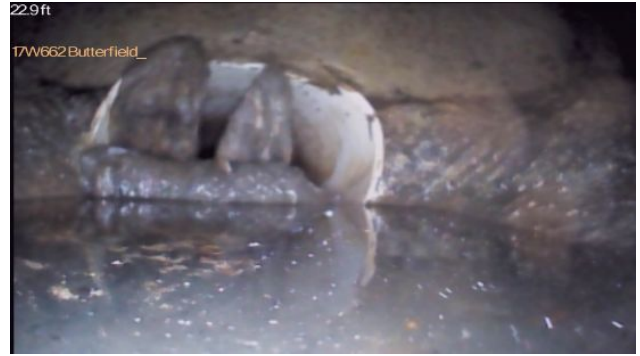
An obstruction, which appears to be in-organic, was noted in the lateral pipe at approximately 24 feet from the clean out (inside manhole). The flow was disturbed.

Blockage Noted

Build-up or other debris was noted in the system. We recommend consulting with a cleaning professional for further attention.
