COMMERCIAL INSPECTION REPORT

Prepared For: Smith John

1/16/2024

Inspector: Dave Lammert

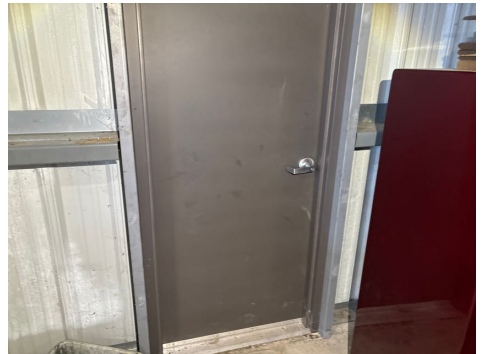
- The exterior walk doors are Storefront.
- The exterior walk doors are Steel clad.
- The loading dock exterior doors were stuck or otherwise unable to be opened at the time of inspection. Recommend inquiring with the seller about the doors and further review by a qualified contractor.

Dock Door Stuck

Page 5	Exterior Doors	<ul style="list-style-type: none"> The loading dock exterior doors were stuck or otherwise unable to be opened at the time of inspection. Recommend inquiring with the seller about the doors and further review by a qualified contractor.
--------	----------------	--

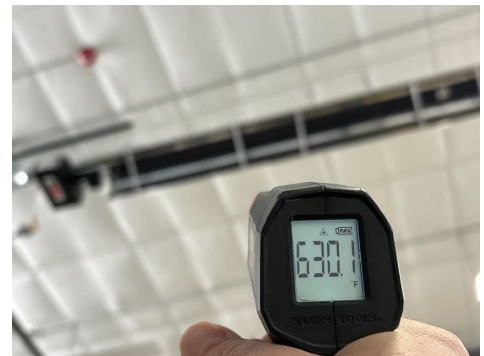
Front Infrared Heater Supply Temp

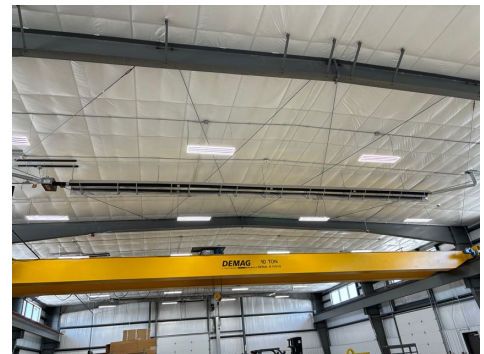
- The front and 2nd warehouse infrared tube heaters were noted to be dripping condensation from the exhaust venting at the time of inspection. This condition may indicate improper flashing or insulation of the vent as it discharges through the roof. Recommend further evaluation by a qualified contractor.

2nd Infrared Heater

Page 17	Heating Equipment Comments	<ul style="list-style-type: none"> The front and 2nd warehouse infrared tube heaters were noted to be dripping condensation from the exhaust venting at the time of inspection. This condition may indicate improper flashing or insulation of the vent as it discharges through the roof. Recommend further evaluation by a qualified contractor.
---------	----------------------------	---

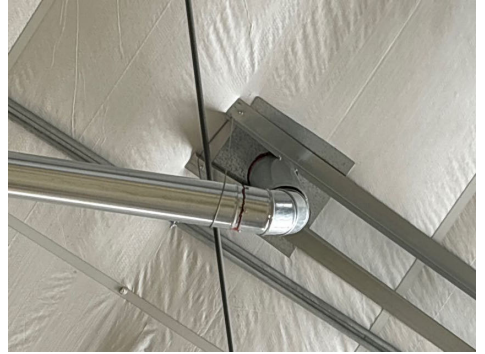
2nd Infrared Heater Drip

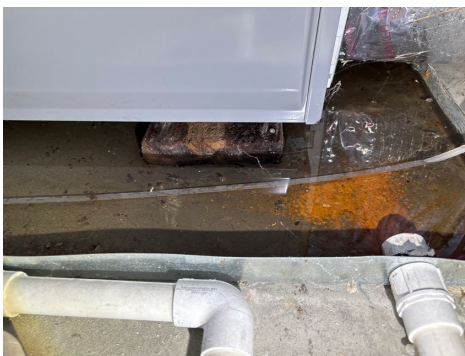
- The high-efficiency furnace exhaust produced condensate fluid that must be properly discharged. The condensate line for this high-efficiency furnace discharged improperly and should be corrected by a qualified HVAC contractor.

Drip Pan Full

Page 20	Condensate Drain	<ul style="list-style-type: none"> The high-efficiency furnace exhaust produced condensate fluid that must be properly discharged. The condensate line for this high-efficiency furnace discharged improperly and should be corrected by a qualified HVAC contractor.
---------	------------------	--

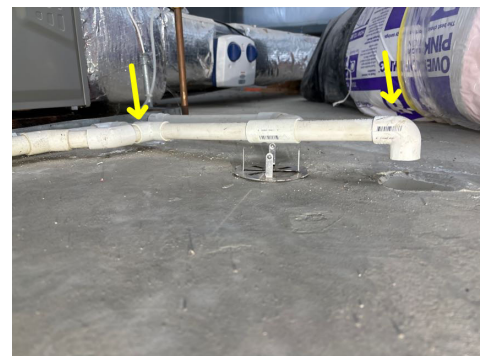
Improper Pitch

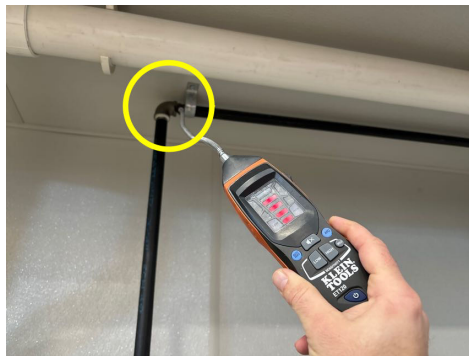
- Gas leakage was noted near the water heater. We recommend the utility company be contacted immediately, this is a **POTENTIAL HAZARD!**

Gas Leak Noted (Near Water Heater)

Page 24	Natural Gas Piping System	<ul style="list-style-type: none"> Gas leakage was noted near the water heater. We recommend the utility company be contacted immediately, this is a POTENTIAL HAZARD!
---------	---------------------------	--

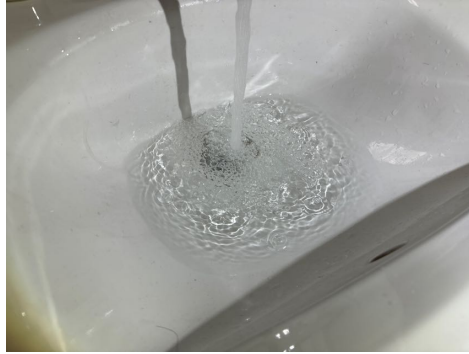
- The sink appeared to drain slowly. There are several things that can cause this, including the accumulation of hair and soap scum in the drain piping. Drain opening chemicals can sometimes help, but often provide only temporary relief. Further review and correction by a qualified plumber is recommended.

Slow Drain-Office Restroom

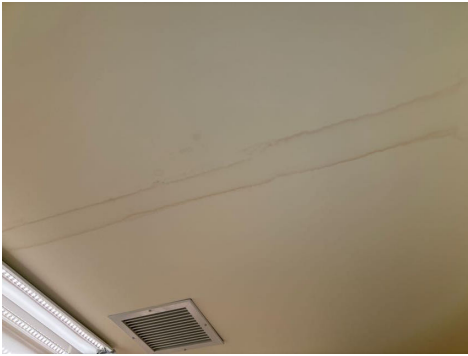
- Moisture staining was noted in the building's entry area, the area tested dry with a moisture meter at the time of inspection. Recommend inquiring with the seller about any previous roof/condensation leaks and any repairs made to the area.

Ceiling Stains

Page 30	Ceilings	<ul style="list-style-type: none"> Moisture staining was noted in the building's entry area, the area tested dry with a moisture meter at the time of inspection. Recommend inquiring with the seller about any previous roof/condensation leaks and any repairs made to the area.
---------	----------	---

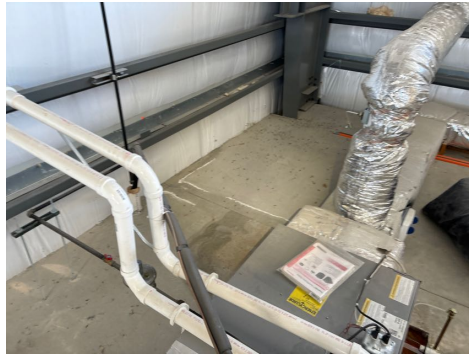
Area Above Stain

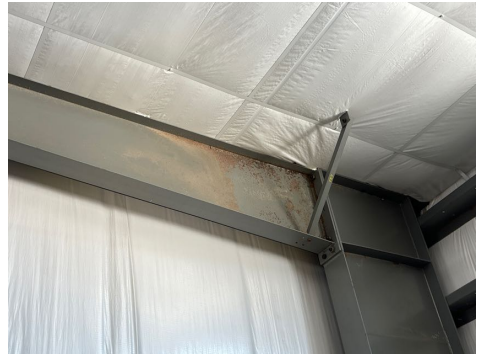
Area Above Staining

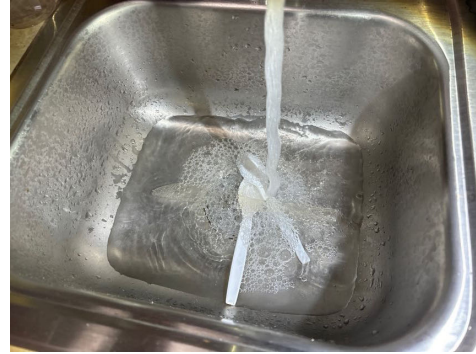
The sink drains slowly. There are several things that can cause this, including the accumulation of grease and soap scum in the drain piping. Drain opening chemicals can sometimes help, but often provide only temporary relief. Further review and correction by a qualified plumber is recommended.

Slow Drain

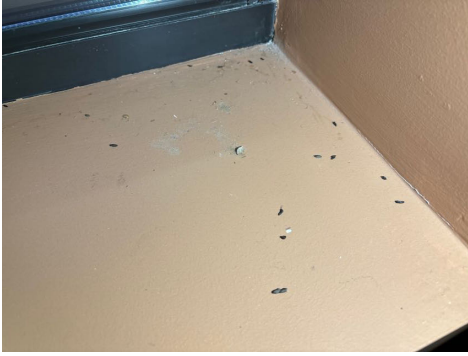
- The office and warehouse had moderate amounts of rodent feces visible. Recommend further evaluation by a qualified pest inspector to determine if the infestation is active.

Pest Droppings-Office

Page 33	Pests: Interior	<ul style="list-style-type: none"> The office and warehouse had moderate amounts of rodent feces visible. Recommend further evaluation by a qualified pest inspector to determine if the infestation is active.
---------	-----------------	--

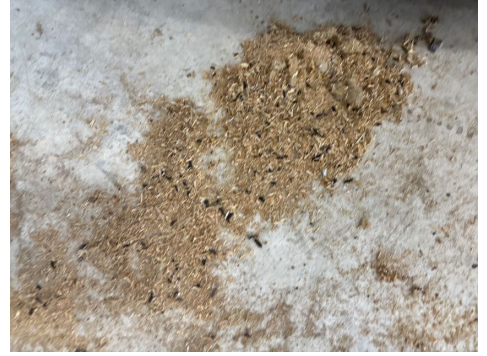
Pest Droppings-Warehouse
