COMMERCIAL INSPECTION REPORT

Prepared For: Client Name

8/22/2024

1234 Address Rd
, IL

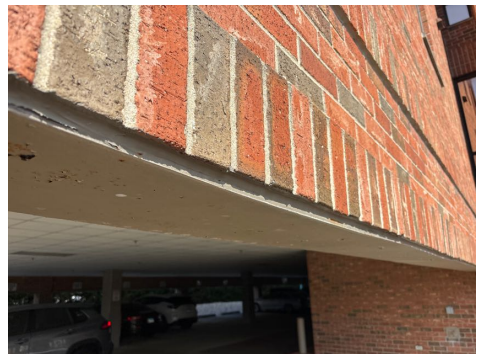
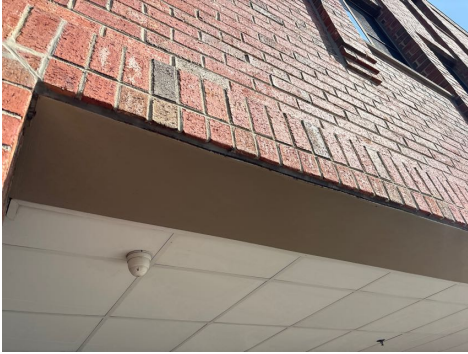
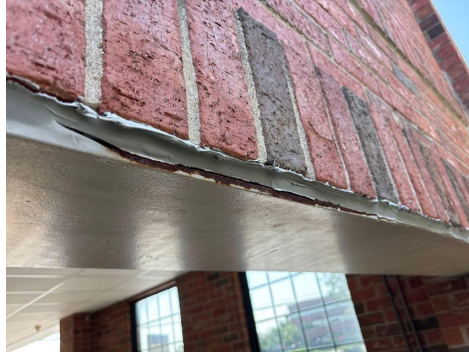
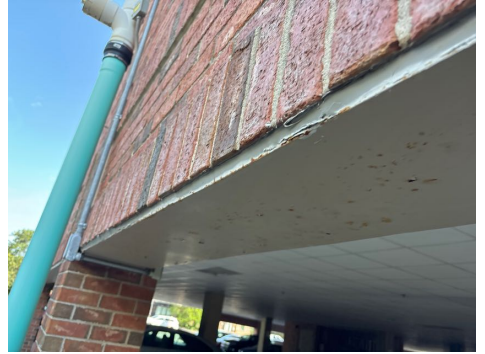
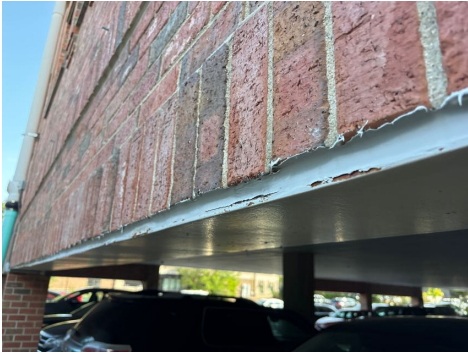
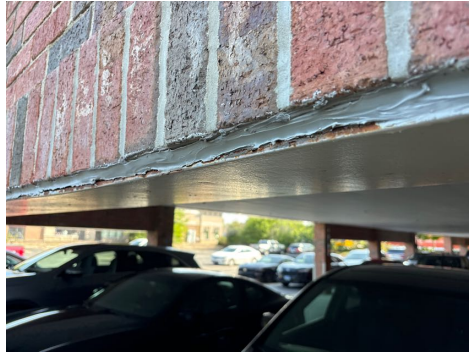
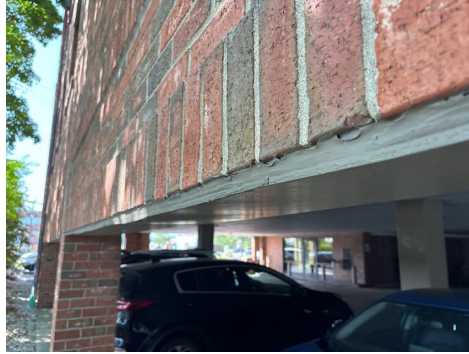
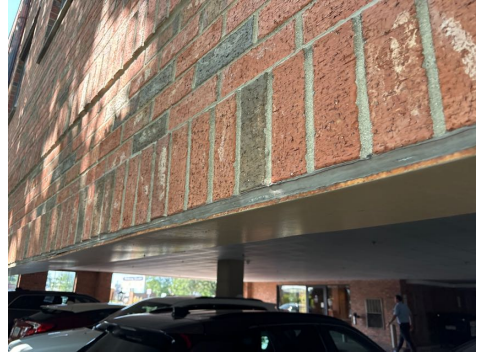
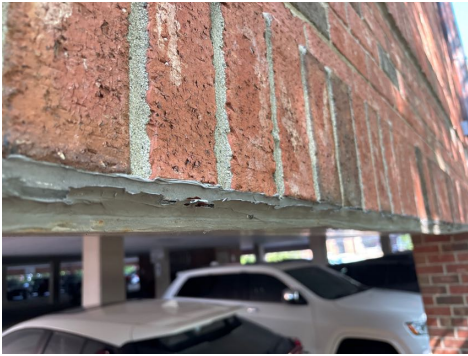
- Typical caulking maintenance is recommended at one or more areas in order to prevent moisture damage to the underlying wall surfaces.
- The majority of the steel lintel(s) of the garage area were found to no longer be flat and typical but rather have distortions and ripples. This is a sign of moisture and metal fatigue. Lintels are an essential part of the structure of the building and further review by a qualified structural contractor is recommended to determine the proper repair.

Lintel Distortion

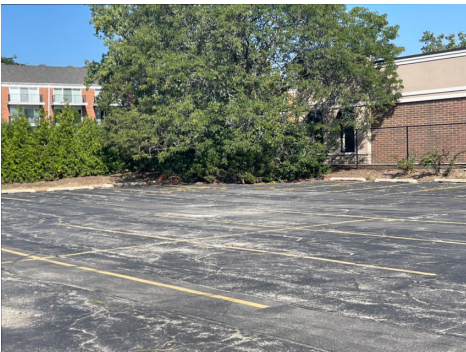
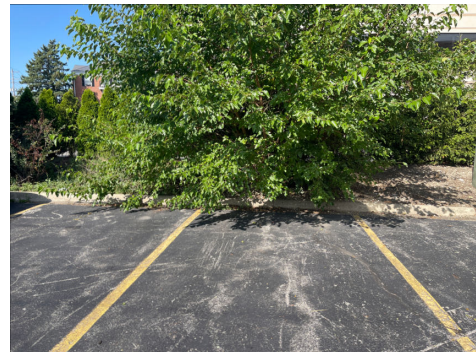
- Vegetation was generally overgrown and needed to be cut back.

Overgrown Vegetation

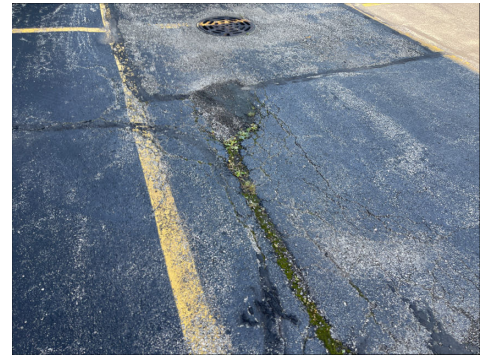
Pot holes

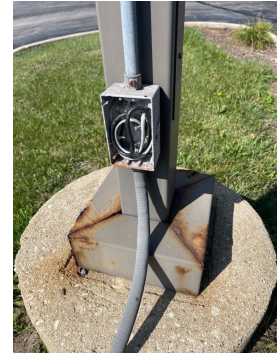
- The electric connection(s) for the parking light are open and exposed. These should be within sealed weather tight connections for not only pedestrian safety but function.

Open Electric

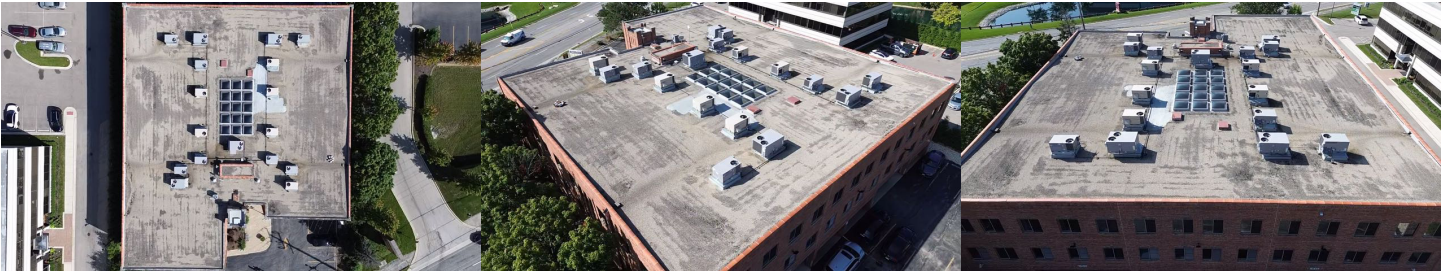
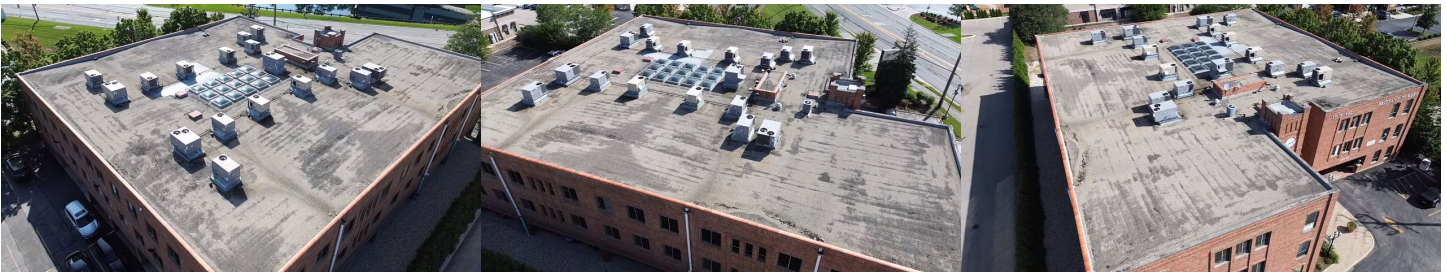
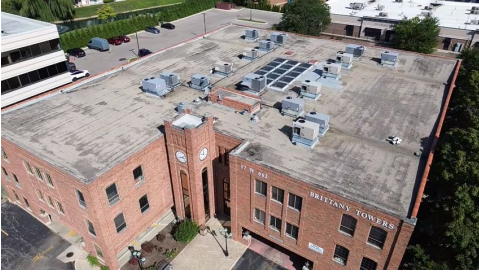
- The roofing material appeared to be older. Recommend periodic monitoring of the roofing for eventual replacement.

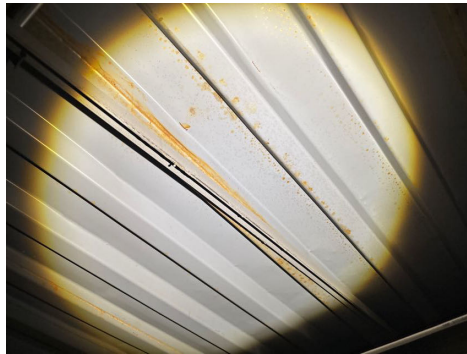
- No visible signs of issues were noted to the sheathing of the building. However, some areas may be hidden from view. Continued monitoring is recommended.

View of Sheathing

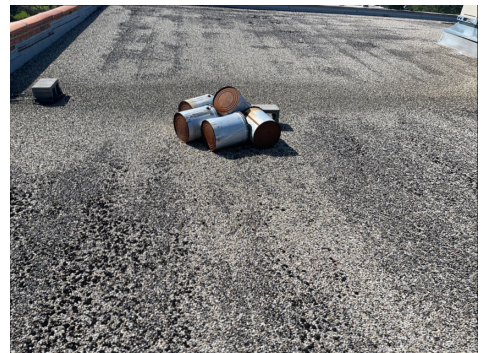
Debris

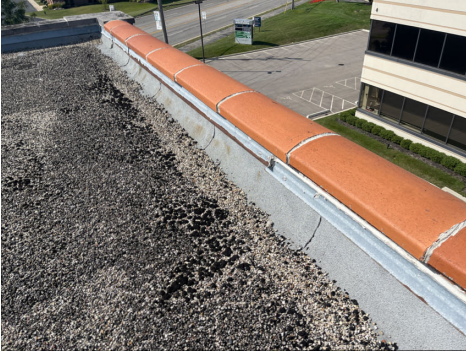
- The parapets appeared to be in satisfactory condition at the time of inspection.
- The parapet coping or flashing was noted to be sealed with caulk at the time of inspection. Caulk sealing can be an effective waterproofing method for a period of time. However, the seals will require periodic maintenance to ensure they remain waterproof.

View of Parapet

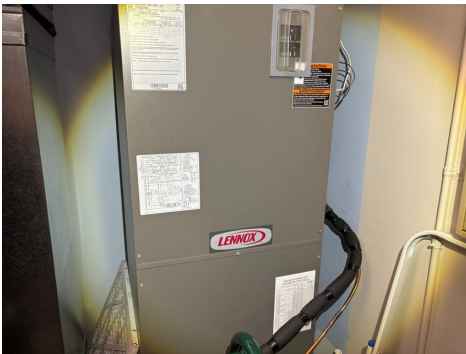
- These units responded to normal controls and operated as intended. There are no current service records that we could locate, (usually they are attached to the equipment or nearby in the same room). We recommend that these units be serviced at least twice annually to maintain and extend the life of the equipment. Since we are uncertain as to whether regular servicing of this equipment has been done and are only able to inspect the unit visually from the exterior, we recommend that you have an HVAC technician service and examine this unit as needed. It may also be appropriate to enter into a maintenance contract with a commercial HVAC company.
- **The 1st floor package unit is at or very near the average statistical life expectancy. Budgeting for replacement is recommended.**

Suite 200 Air Handler

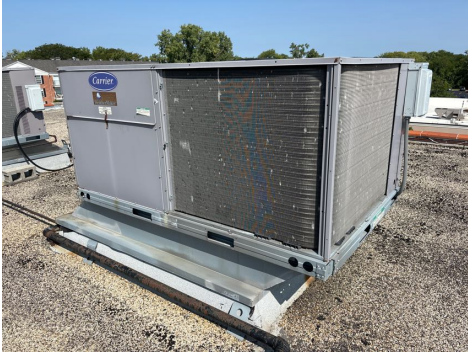
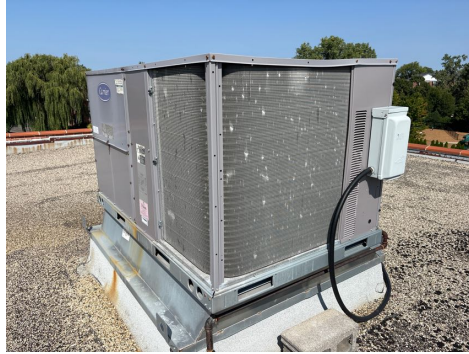
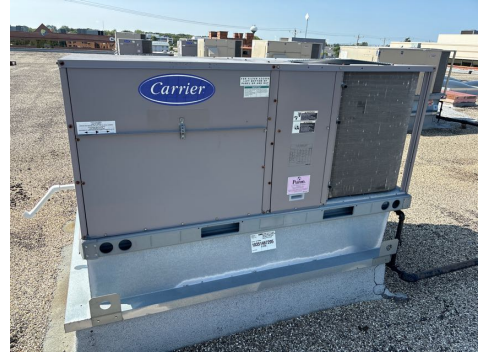
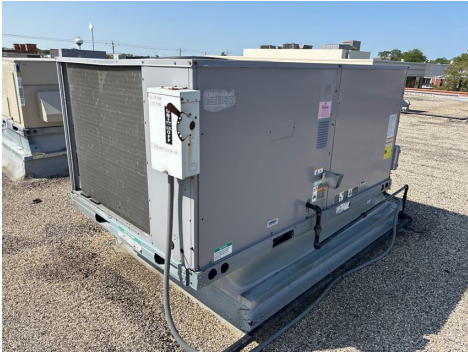
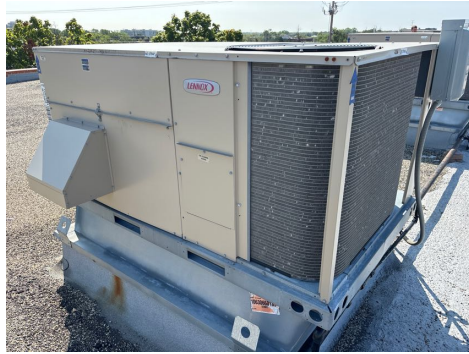
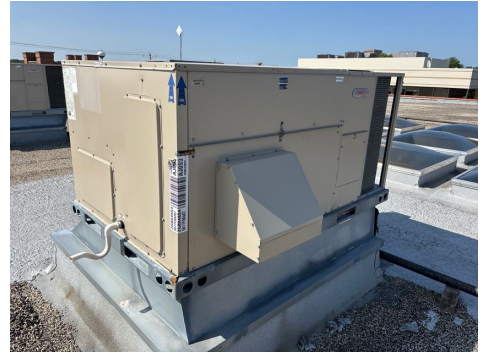
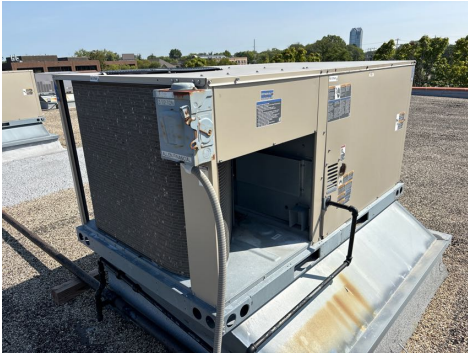
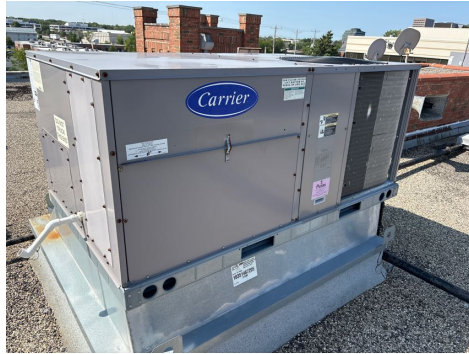
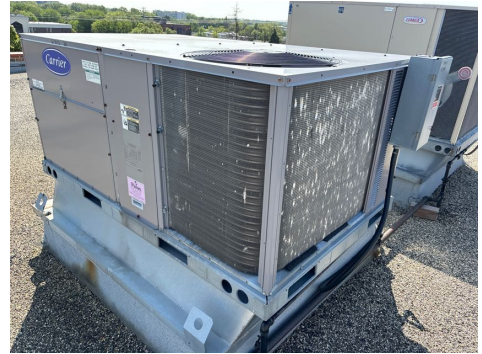
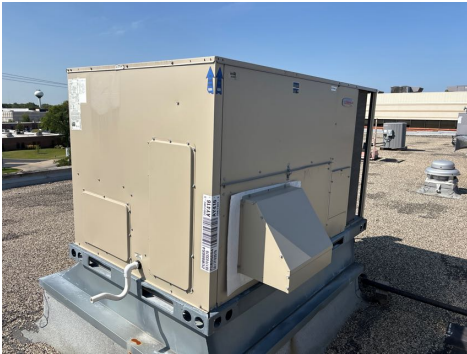
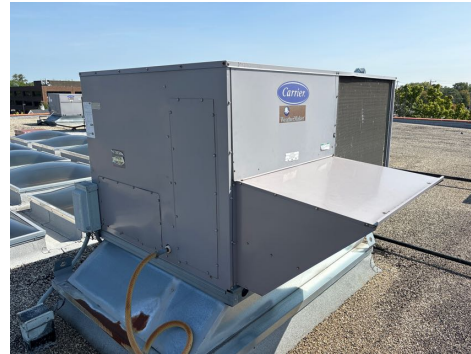
Suite 303 RTU

Suite 203 RTU

Unlabeled RTU

Suite 306 RTU

Suite 206 RTU

Suite 307 RTU

Suite 305 RTU

Suite 207 RTU

Suite 201 RTU

Suite 304 RTU

Atrium RTU

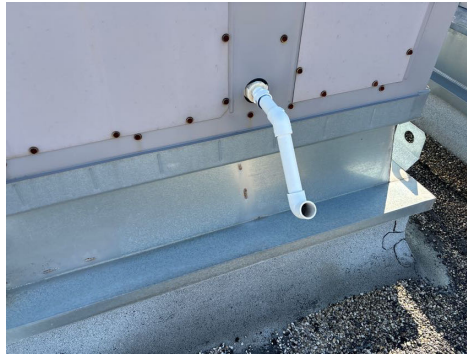
- Condensate from the evaporator coils of the HVAC rooftop units was discharged onto the surface of the roof. This condition is improper. Condensate should be discharged off the roof or to a roof drain.

All Units Discharge to Roof

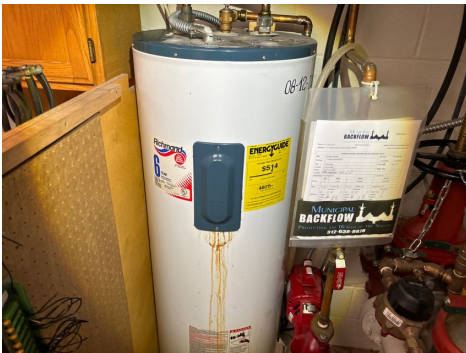
- This water heater was actively leaking and should be shut off, drained immediately and an an evaluation and any necessary work performed by a qualified HVAC or plumbing contractor.
- These water heaters appeared to be past their design life and may need replacement soon.

View of Common Water Heater

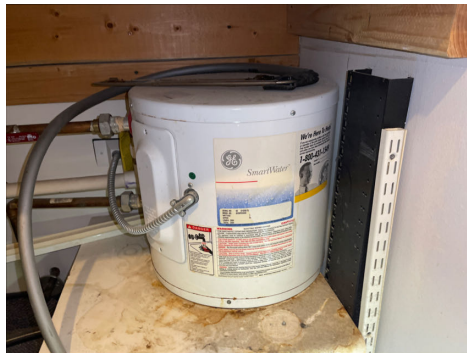
View of Water Heater

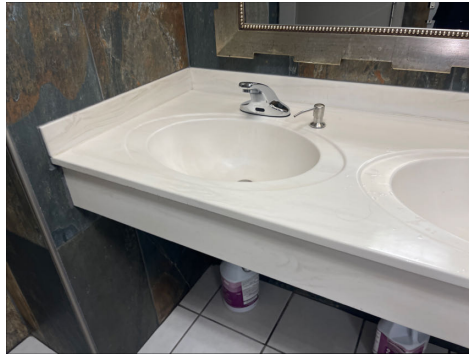
- In the Women's restroom on the 2nd floor the sink did not function.

Did not Function

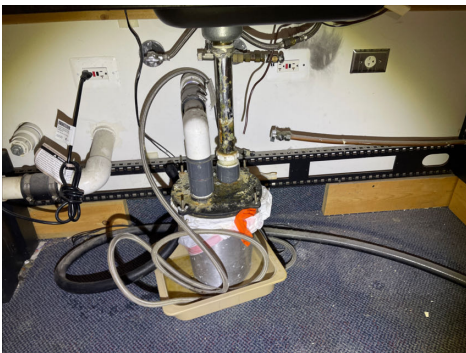
- Leaking noted at the sink drain at unit 206.

Sink Leak 206

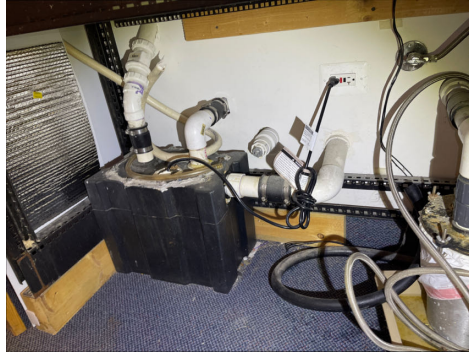
- The sewer ejector pump was not able to be tested, the source of the waste material was not determined.

View of Ejector

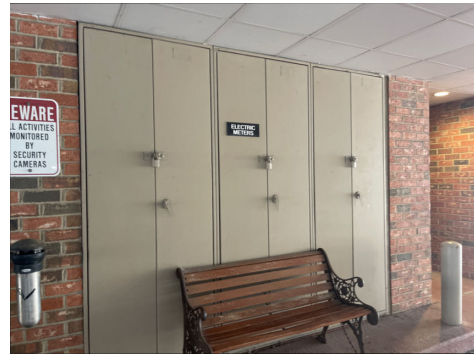
Locked Doors

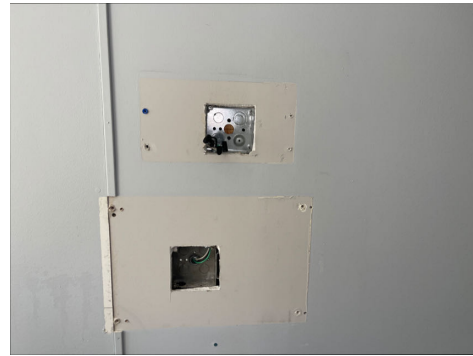
- A junction box installed in unit 206 was missing a cover and energized electrical components were exposed to touch. This condition is an electrical shock/electrocution hazard. A listed cover should be installed.
- Open electrical connections were observed in the undersink area of the Suite 302 Kitchenette.

Open Box 206

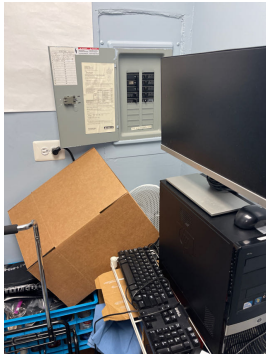
Poor Clearances 307

- This electrical distribution panel did not have proper clearances for working space or to provide quick access for an emergency disconnect. This condition should be corrected for safety reasons. The clear working space required in front of an electrical panel is 30" wide (or at least as wide as the service equipment) by 36" deep with a minimum headroom clearance of 6 feet-6 inches. 307 & 200

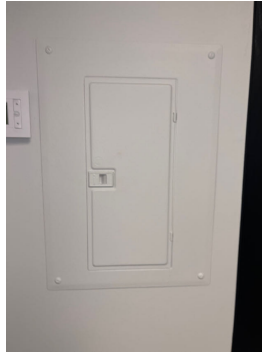
- The inspector was unable to remove the dead front cover of this electrical distribution panel and electrical components inside the panel were not inspected. This condition should be corrected and the service panel contents inspected by a qualified electrical contractor.

Panel 302 Painted Shut

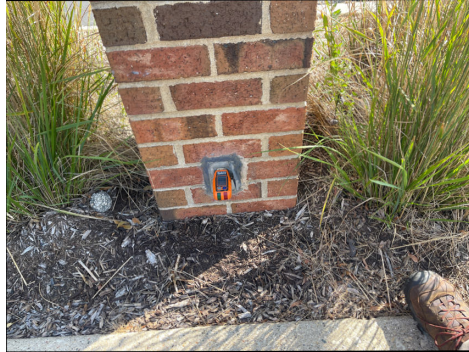
- Ground fault circuit interrupter (GFCI) exterior electrical receptacles were generally old, with many responding poorly or not at all. Any such receptacles should be brought into good working order by a qualified electrical contractor.

Not Working

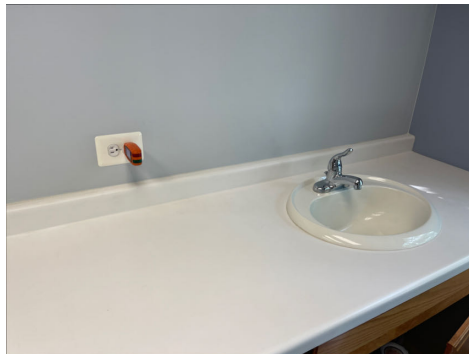
- No ground fault circuit interrupter (GFCI) protection of electrical receptacles was provided in unit 206

Non GFCI Outlet 206

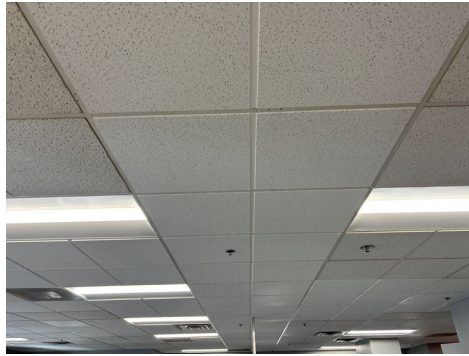
- These stains APPEAR to be the result of past, rather than current roof leakage or condensation leaks. However it is not possible to be absolutely certain.

View of Suite 300 Ceiling

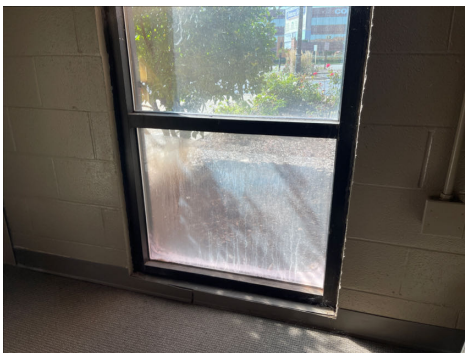
- The vacuum seal has failed ("lost seal") in the insulated glass in some of the windows. While the "fogging" of the glass is largely cosmetic, there is an accompanying loss of insulation value. This condition can only be corrected by replacement of the entire, factory assembled glazing unit by a qualified window contractor.

Lost Seal

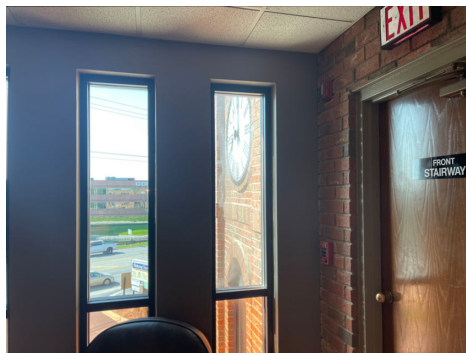
Failed Thermal Pane Seal

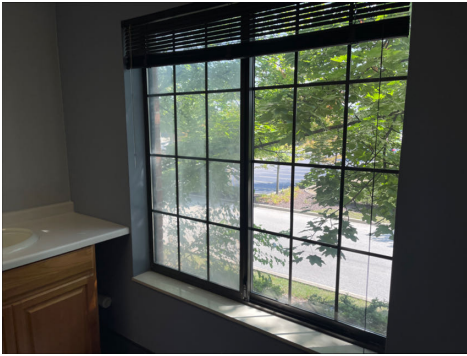
Lost Seal

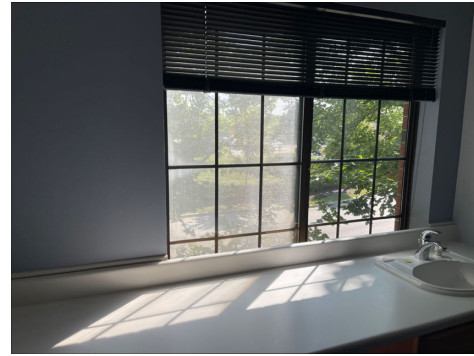
Lost Seal

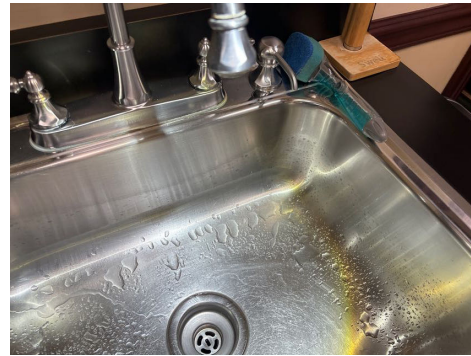
The faucet was dripping. This is wasteful and can substantially increase the water bill. Proper correction is recommended.

Dripping Faucet-Suite 200

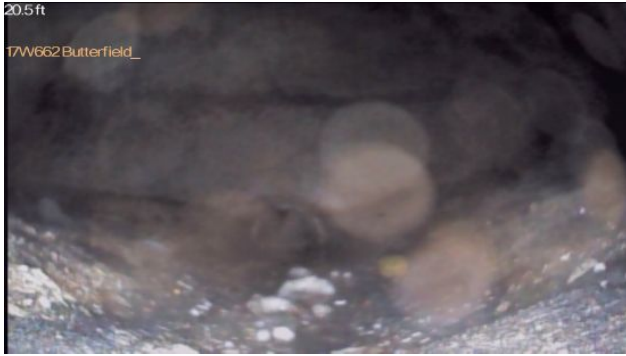
Inside Manhole

An obstruction, which appears to be in-organic, was noted in the lateral pipe at approximately 24 feet from the clean out (inside manhole). The flow was disturbed.

Build-up or other debris was noted in the system. We recommend consulting with a cleaning professional for further attention.
