COMMERCIAL INSPECTION REPORT

Prepared For: Smith John

1/16/2024

Inspector: Dave Lammert

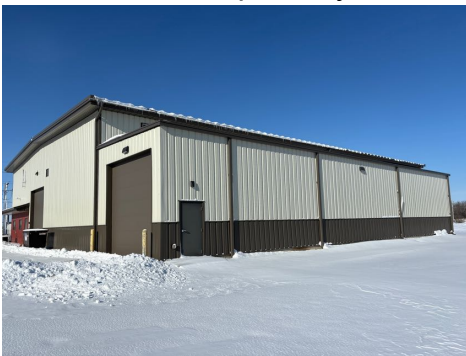
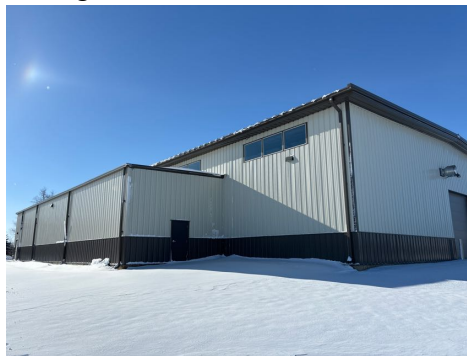
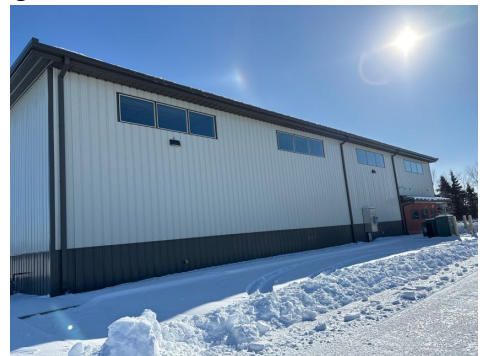
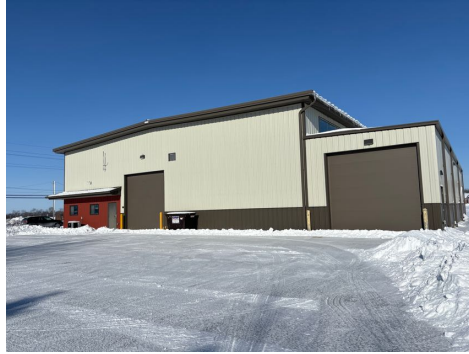
- metal siding has been used as the cladding on this building.
- Typical caulking maintenance is recommended at one or more areas of the siding in order to prevent moisture damage to the underlying wall surfaces.
- Maintenance Recommendations:
 - Maintain the buildings foundation grade to keep at least 6 inches clearance from the ground to siding bottom.
 - Periodically wash the siding surfaces to remove stains.
 - Monitor and repair any areas of siding that become loose or damaged.

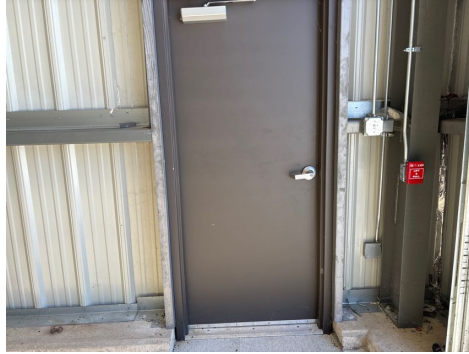
- The exterior walk doors are Storefront.
- The exterior walk doors are Steel clad.
- The loading dock exterior doors were stuck or otherwise unable to be opened at the time of inspection. Recommend inquiring with the seller about the doors and further review by a qualified contractor.

Dock Door Stuck

Page 5	Exterior Doors	<ul style="list-style-type: none"> The loading dock exterior doors were stuck or otherwise unable to be opened at the time of inspection. Recommend inquiring with the seller about the doors and further review by a qualified contractor.
--------	----------------	--

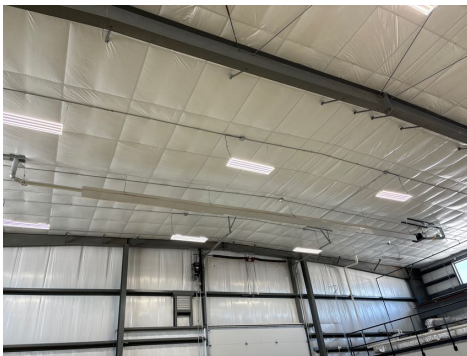
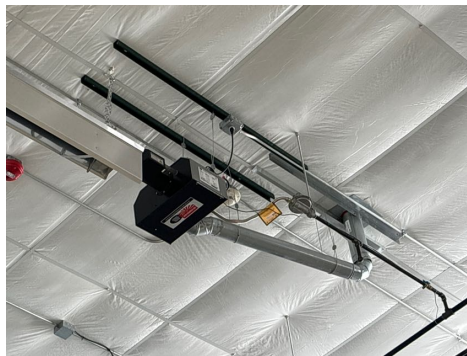
Front Infrared Heater

- The front and 2nd warehouse infrared tube heaters were noted to be dripping condensation from the exhaust venting at the time of inspection. This condition may indicate improper flashing or insulation of the vent as it discharges through the roof. Recommend further evaluation by a qualified contractor.

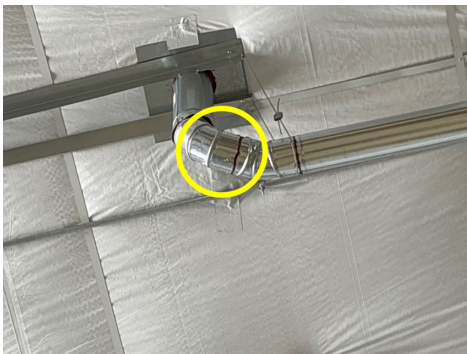
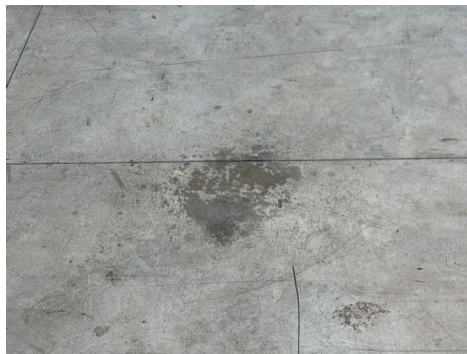
Front Infrared Heater Drip

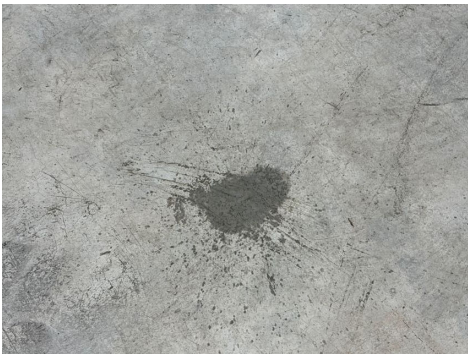
2nd Infrared Heater Drip

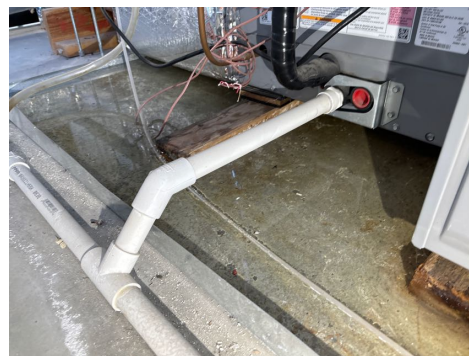
- The high-efficiency furnace exhaust produced condensate fluid that must be properly discharged. The condensate line for this high-efficiency furnace discharged improperly and should be corrected by a qualified HVAC contractor.

Drip Pan Full

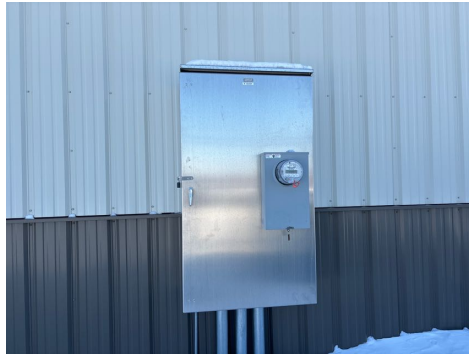
View of Electric Meter

- The electrical meter appeared to be in satisfactory condition at the time of inspection.

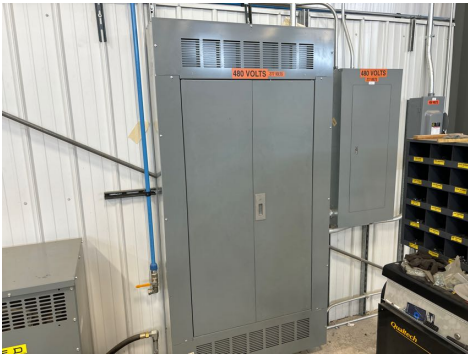
View of Service Panel

- The main electrical service panel appeared to be in satisfactory condition at the time of inspection.

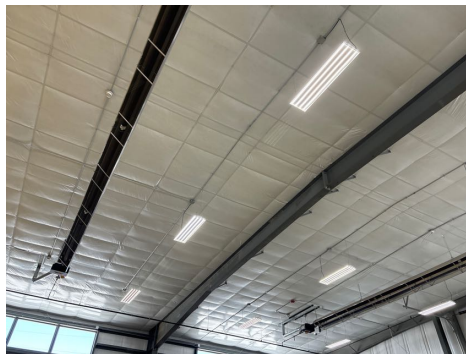
- Newer modern lighting has been installed.

View of Lighting

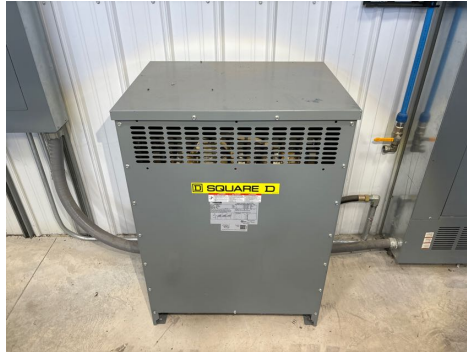
View of Transformer

- The electrical transformer appeared to be in satisfactory condition at the time of inspection.

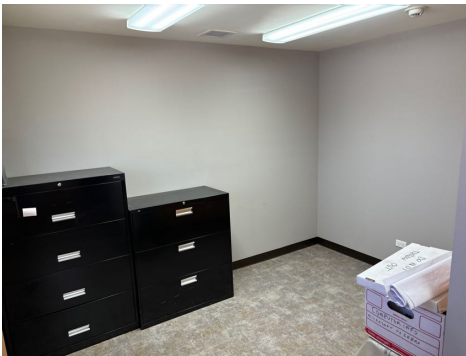
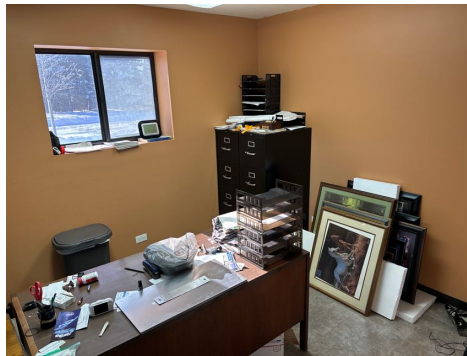
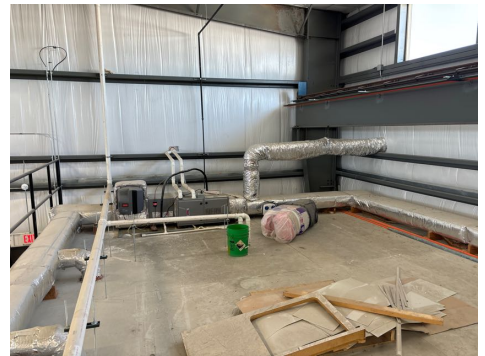
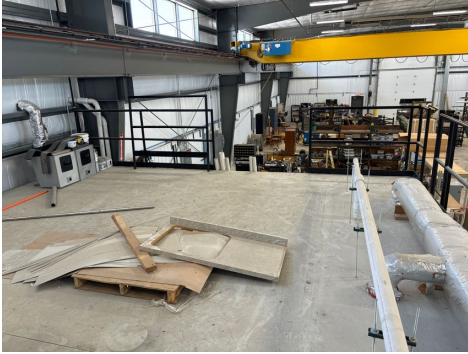
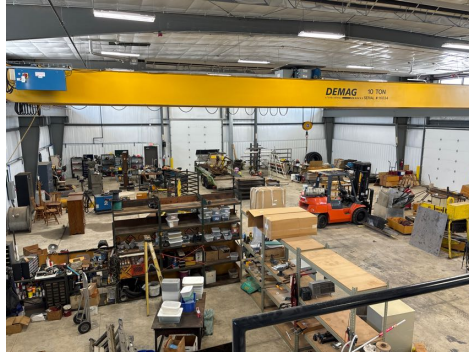
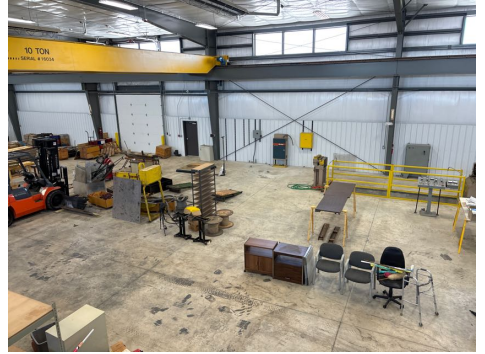
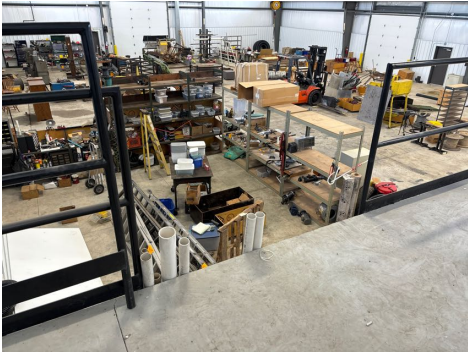
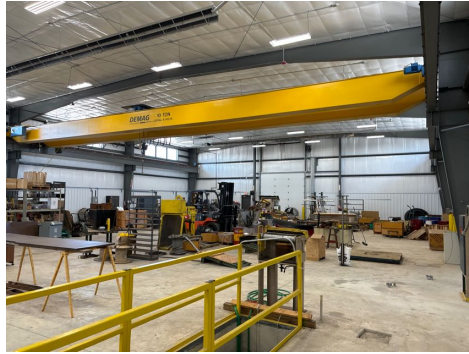
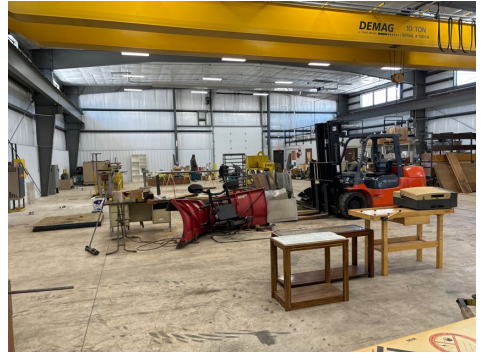
- Small settling cracks were noted at several areas, this is normal and to be expected.
- Walls and wall coverings appear to be in serviceable condition

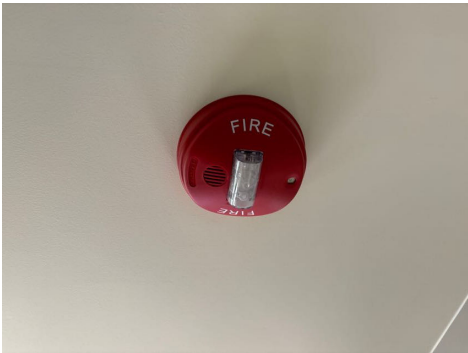
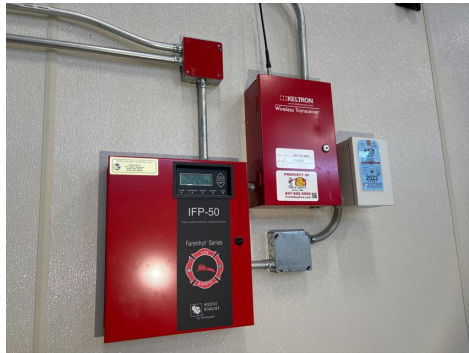
View of alarm system

- A fire alarm system appears to be installed for this structure, however, these are beyond the scope of this inspection.

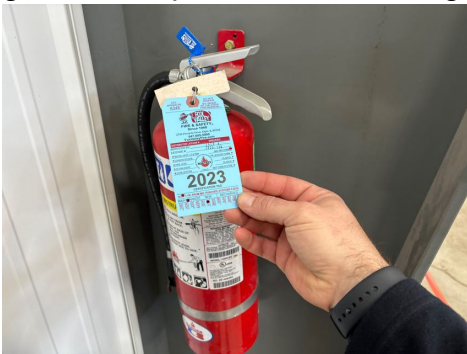
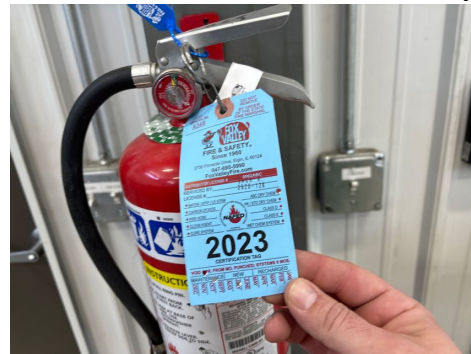
View of extinguisher

- There appear to be an adequate number of fire extinguishers installed for this facility,
- The tags on the represented fire extinguishers do not appear to be with the current date cycle.

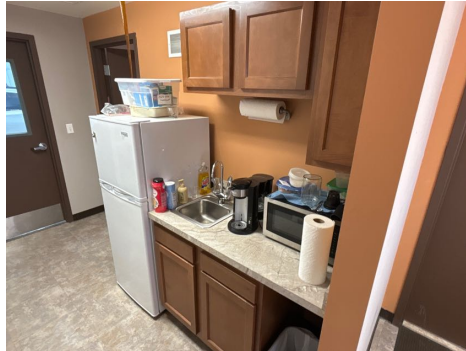
General View of Kitchen

The kitchen appliances, fixtures and structural components were reviewed during this inspection under the conditions noted in the Standard Inspection Agreement. During this review, no visible signs of defects, leaks, or other issues were discovered unless noted in the sub sections below.

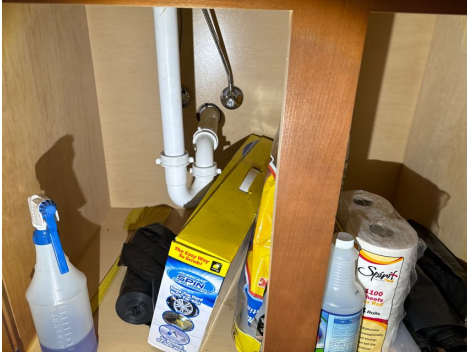
General View of Sink Drain

The sink drains slowly. There are several things that can cause this, including the accumulation of grease and soap scum in the drain piping. Drain opening chemicals can sometimes help, but often provide only temporary relief. Further review and correction by a qualified plumber is recommended.

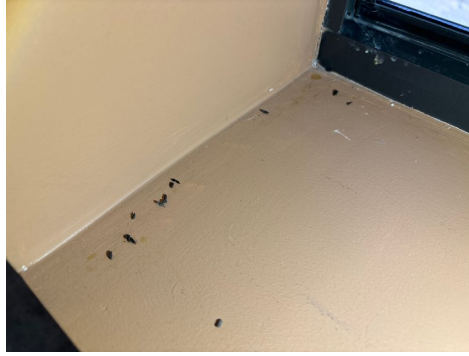
Pest Droppings-Office

- The office and warehouse had moderate amounts of rodent feces visible. Recommend further evaluation by a qualified pest inspector to determine if the infestation is active.
